Manhole Inspection Summary

Manhole # S45S__002MH

Location Address: **1109 haubert st**

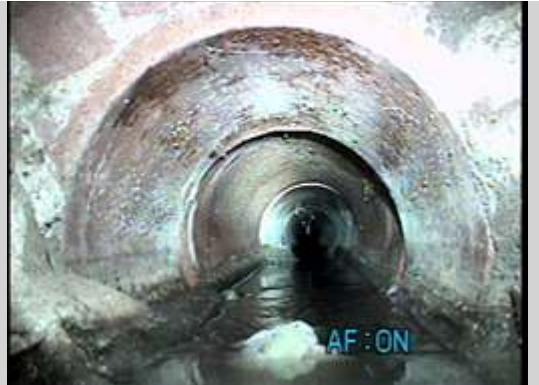
12 O'Clock Outflow

10 in. Circular Gravity Sewer
Pipe Out @ 12 O'Clock

Pipe Material: **Clay** ☐ Pipe Lined

Invert Depth: 13.00 (ft.) Flow Characteristics: **Fast**

Deposits: ☒ None ☐ Mud ☐ Sludge ☐ Debris ☐ Grease

Infiltration: **None** Pipe Seal Cond: **Unknown**

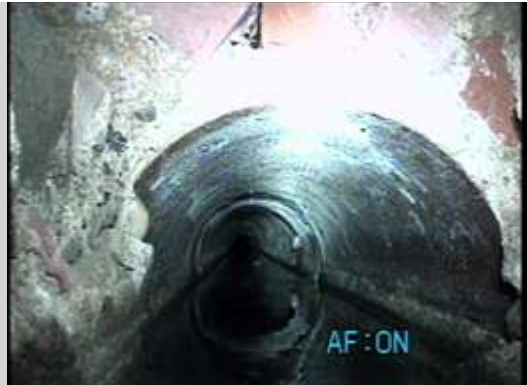
6 O'Clock Inflow

10 in. Circular Gravity Sewer

Pipe In @ 6 O'Clock

Pipe Material: **Clay** ☐ Pipe Lined

Invert Depth: **12.92** (ft.) Flow Characteristics: **Fast**

Deposits: ☒ None ☐ Mud ☐ Sludge ☐ Debris ☐ Grease

Infiltration: **None** Pipe Seal Cond: **Unknown**

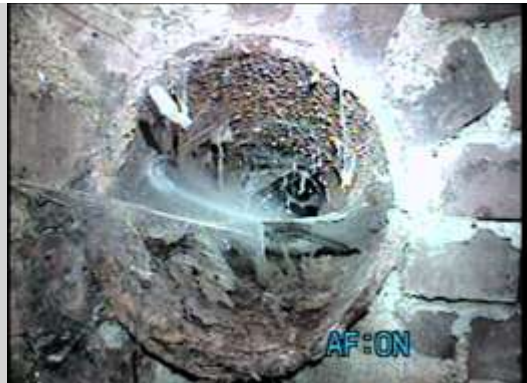
7 O'Clock Inflow

8 in. Circular Gravity Sewer

Pipe In @ 7 O'Clock

Pipe Material: **Clay** ☐ Pipe Lined

Invert Depth: **4.66** (ft.) Flow Characteristics: **None**

Deposits: ☒ None ☐ Mud ☐ Sludge ☐ Debris ☐ Grease

Infiltration: **None**

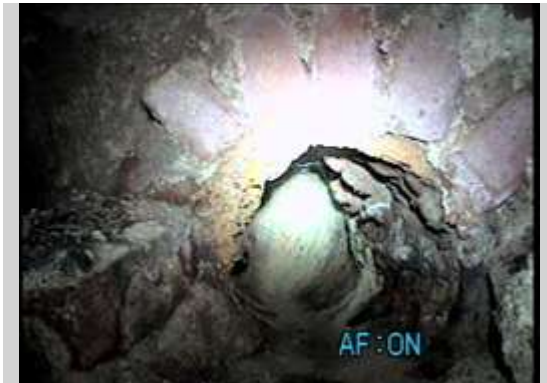
Drop In @ 7 O'Clock

Drop: **Outside Direct**

Drop Condition: **Open**
